Manhole Inspection Summary

Manhole # S35CC2013MH

Insp Date: **3/30/07 9:33 AM**

Location Address: **5925 BELLONA AVE**

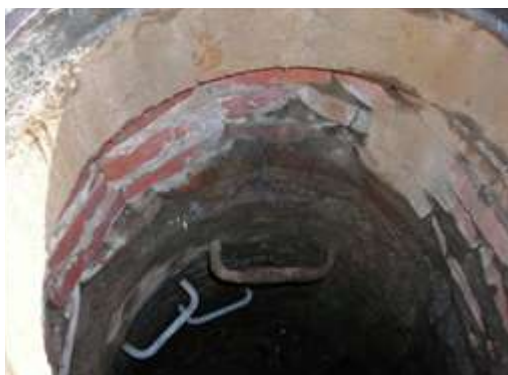
Defect

Frame leaks. Adjustment deterioration and infiltration. Corbel infiltration.

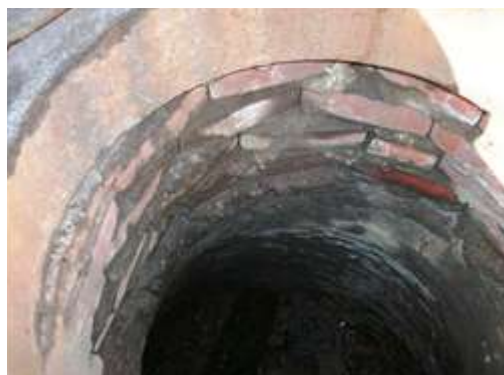
Defect

Frame leaks. Adjustment deterioration and infiltration. Corbel infiltration - other side.

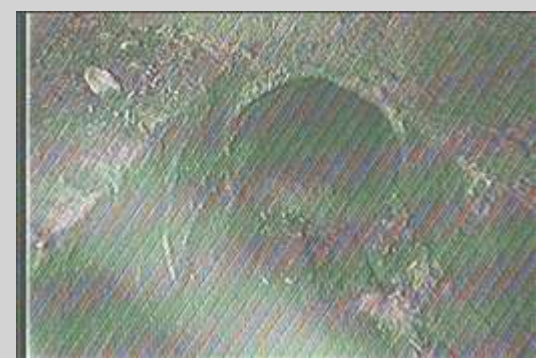
8 in. Circular Gravity Sewer Pipe Out @ 12 O'Clock

Channel deterioration.

Infiltration: **None** Pipe Seal Cond: **Cracked**

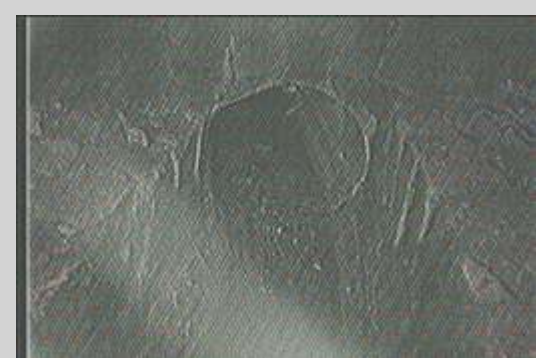
8 in. Circular Gravity Sewer Pipe In @ 3 O'Clock

Infiltration: **None** Pipe Seal Cond: **Cracked**

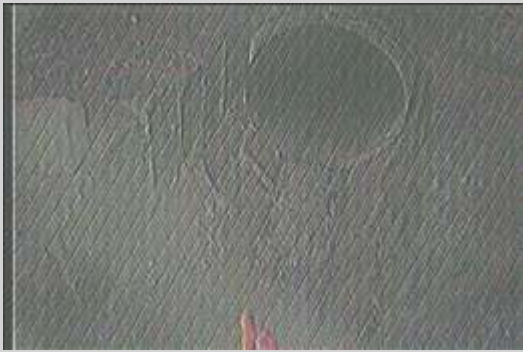
Pipe In @ 6 O'Clock

Infiltration: **Evidence** Pipe Seal Cond: **Cracked**

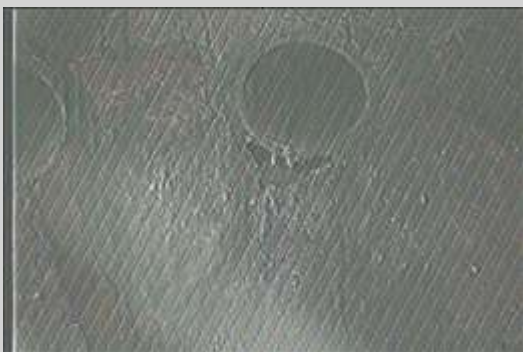
Pipe In @ 7 O'Clock

Infiltration: **None** Pipe Seal Cond: **Broken**
